FLAHERTY-GIAVARA ASSOCIATES NEW HAVEN CT  
NATIONAL DAM SAFETY PROGRAM. LITTLE CHOCONUT WATERSHED SITE 2A --ETC(U)  
JUN 81 H C FLAHERTY

REPORT DOCUMENTATION PAGE		READ INSTRUCTIONS BEFORE COMPLETING FORM
1. REPORT NUMBER	2. GOVT ACCESSION NO.	3. RECIPIENT'S CATALOG NUMBER
	AD-A105727	
4. TITLE (and Subtitle) Phase I Inspection Report Little Choconut Watershed Site 2A Dam Susquehanna River Basin, Broome County, N.Y. Inventory No. 720		5. TYPE OF REPORT & PERIOD COVERED Phase I Inspection Report National Dam Safety Program

16. SUPPLEMENTARY NOTES		
17. KEY WORDS (Continue on reverse side if necessary and identify by block number) Dam Safety National Dam Safety Program Visual Inspection Hydrology, Structural Stability Little Choconut Watershed Site 2A Dam Broome County Susquehanna River Basin

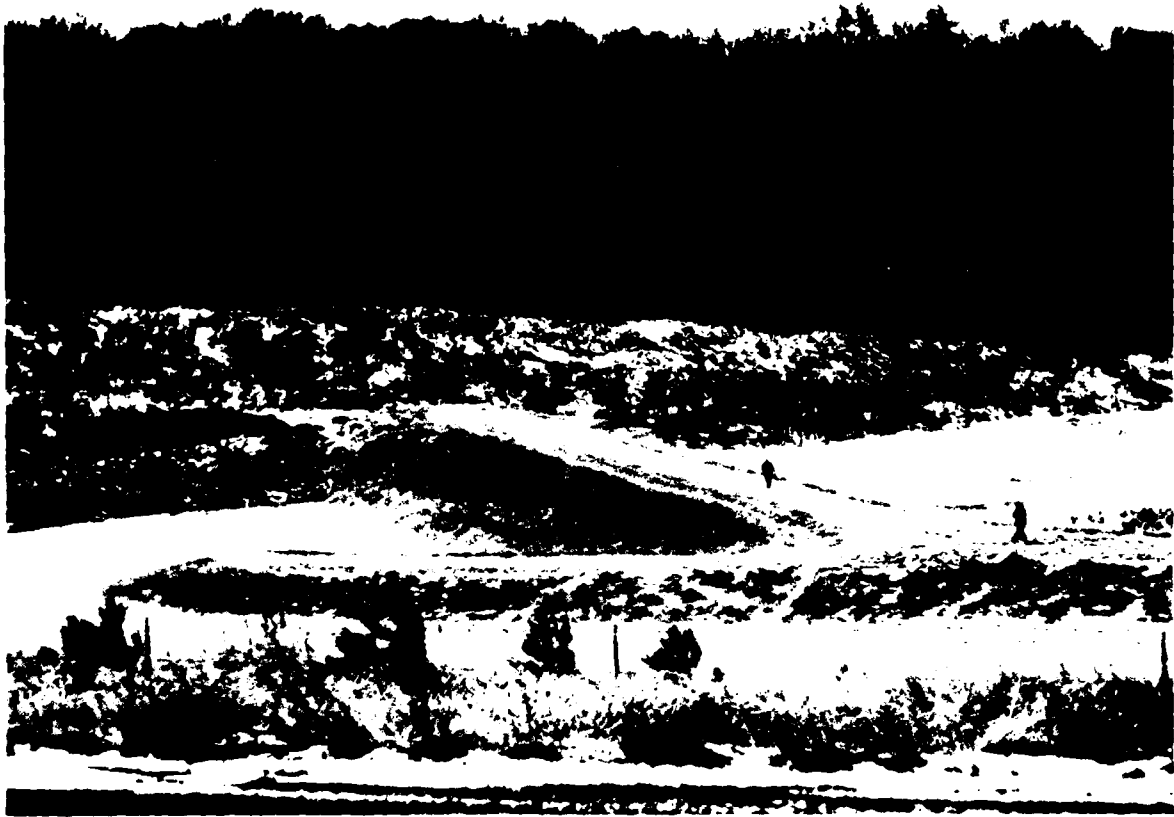
PHOTO #1: Overview of  
Little Choconut Watershed Site 2A Dam  
Inventory No. NY 720

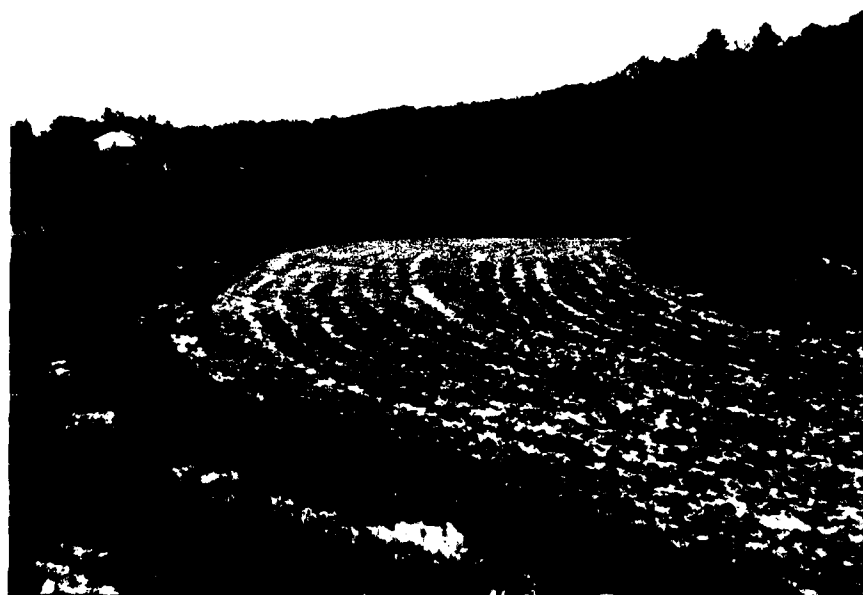
The dam has an 80 foot wide earthen spillway excavated into the left abutment. The approach channel, spillway crest, and discharge channel all have a thick, heavy grass cover and are in good condition (See Photos No. 8 and 9).

PHOTO #9: Crest of emergency spillway looking downstream
